Hydraulic Model Investigation Of Marsh Creek Dam Principal Spillway In Contra Costa County, California

ARS-NC-35 February 1976

Study conducted by the Agricultural Research Service UNITED STATES DEPARTMENT OF AGRICULTURE

Fred W. Blaisdell and Clayton L. Anderson¹

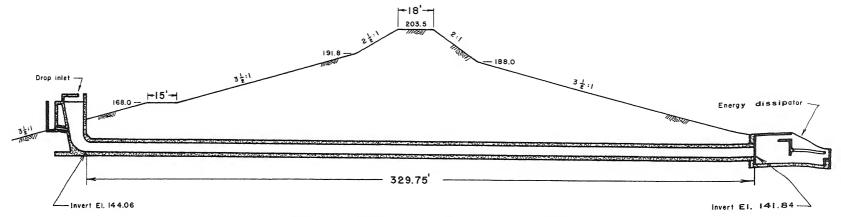
FIGURE 1.—Centerline section through principal spillway.

A section through the principal spillway is shown in figure 1. The dimensions are "as built." In plan the barrel is slightly curved to follow the sandstone foundation with minimum excavation. Figure 2 shows the inlet and figure 3 shows the U.S. Bureau of Reclamation Type VI energy dissipator at the conduit exit.

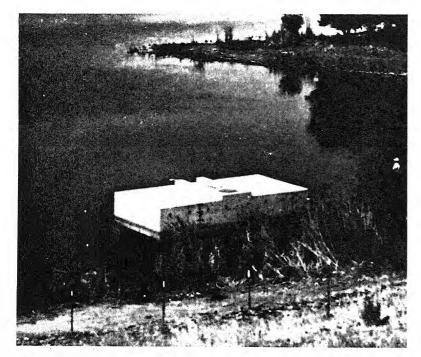
FIGURE 2.—Inlet.

The studies were concerned primarily with the hydraulics of the inlet structure shown in figure 2. The dimensions of the drop inlet pertinent to this study are shown in figure 4.

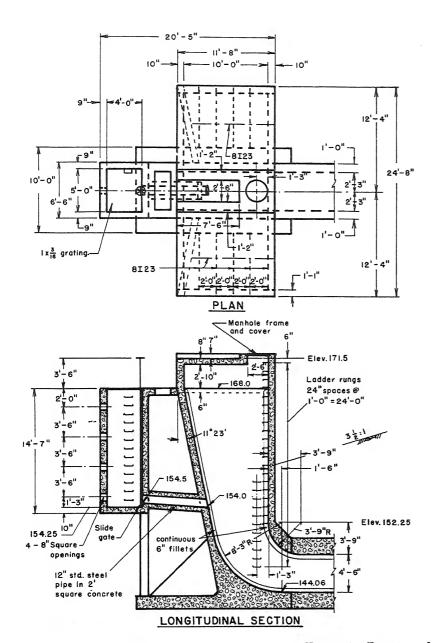
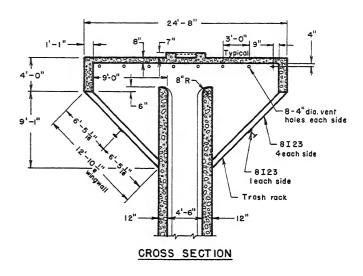
FIGURE 4.—Prototype drop inlet dimensions.

The model investigation was planned to study only the hydraulic performance of the principal spillway drop inlet. Because it had no effect on the performance, the gated drainage inlet structure on the upstream side of the drop inlet shown in figure 4 was not modeled. Also, the stilling basin was omitted because the energy dissipator was anticipated to have little effect on the performance even though it might affect the discharge at which various flow events occurred.

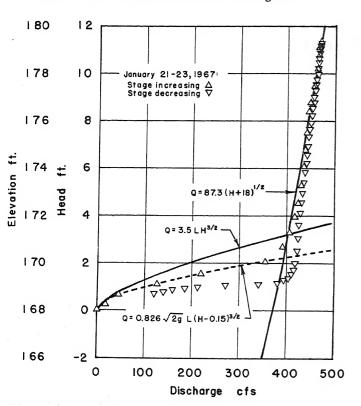
FIGURE 5.—Prototype head-discharge relationships.

6. . . . the recorded inflow hydrograph was routed through the reservoir using the storage-indication procedure. The calculated values of the outflow obtained through this process were plotted against corresponding (in time) pond stages obtained from the record. There was good agreement between measured and computed performance curves especially in the range of conduit control. At the low rates (weir control) the measured head was systematically lower than the predicted one and more so in the falling than in the rising limb of the hydrograph.

Kalkanis' weir flow and conduit control curves have been added to figure 5 to illustrate his comments.

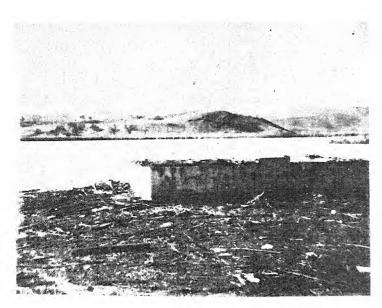
- 1. At 10:10 a.m. the water surface at principal spillway was indicated to be (-) 0.1', by the painted scale on the hood, below the crest which is supposed to be constructed at elevation 168.0'. An audible roar of falling water could be heard even when inside the recorder building on top of the dam. All of the (8) 4" \emptyset vent holes on the north face of the spillway appeared to be partially to completely plugged with debris. (Ref. photo No. 1).

Photo No. 1.—1/27/69 w/s [water surface] at inlet indicated at -01 10:10 a.m.

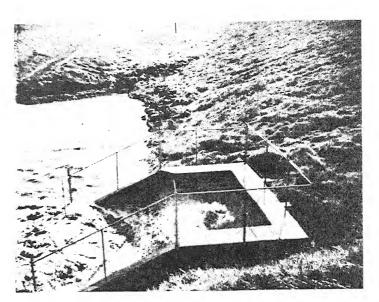
- 2. At 10:15 a.m. the discharge in the energy dissipator was turbulent and it appeared that the $4.5'\times4.5'$ spillway tube was flowing full. (Ref. photos No. 2 & 3).

Photo No. 2.—1/27/69 10:15 a.m. [No air expelled.]

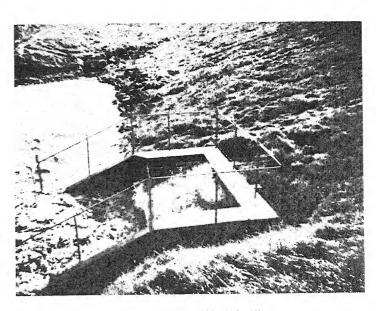
Photo No. 3.—1/27/69 10:15 a.m. [Air transported through the barrel is expelled intermittently.]

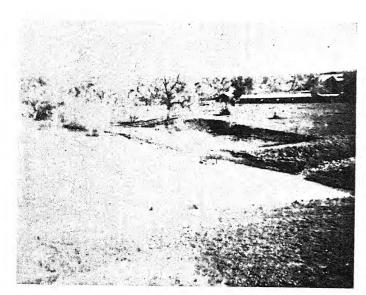
- 3. At 10:25 a.m., while in the recorder building, I realized that the audible flow had ceased. I now estimate the time from when I last consciously heard the flow to when I realized it had stopped to be no more than a few minutes. At 10:32 I recorded the water surface at the spillway hood to be an indicated (—) 0.2'. (Ref. photo No. 4). Later scrutiny of the photo indicated that several of the vent holes appearing partly plugged on photo No. 1 were open in photo No. 4. Although hardly discernible, photo No. 5 shows the outflow area to be tranquil with no visible flow from the dissipator.

Photo No. 5.—1/27/69 10:32 a.m. Spillway stopped flowing.

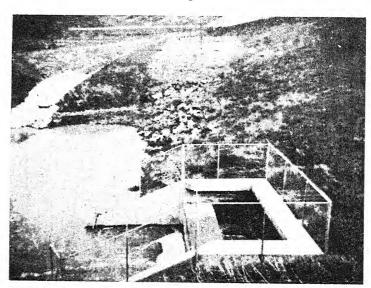
2. Photo No. 7 shows the outflow in the energy dissipator corresponding to the head on the spillway shown in photo No. 6. The flow was about 0.2' below the soffit of the spillway tube.

Photo No. 7.—1/29/69 2:45 p.m. 0.5' below soffit.

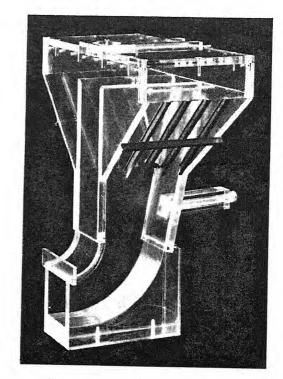
Figure 6.—The model drop inlet.

All critical drop inlet dimensions were modeled to exact scale. However, the wall thickness deviated from exact scale to permit the use of stock thicknesses of plastic. The model inlet is shown in figure 6 and its dimensions are shown in figure 7. The trashrack was made from an extruded plastic I-beam section 0.375 by 0.187 inch whereas the scaled dimensions should have been 0.333 by 0.172 inch. The drop inlet ladders were not modeled.

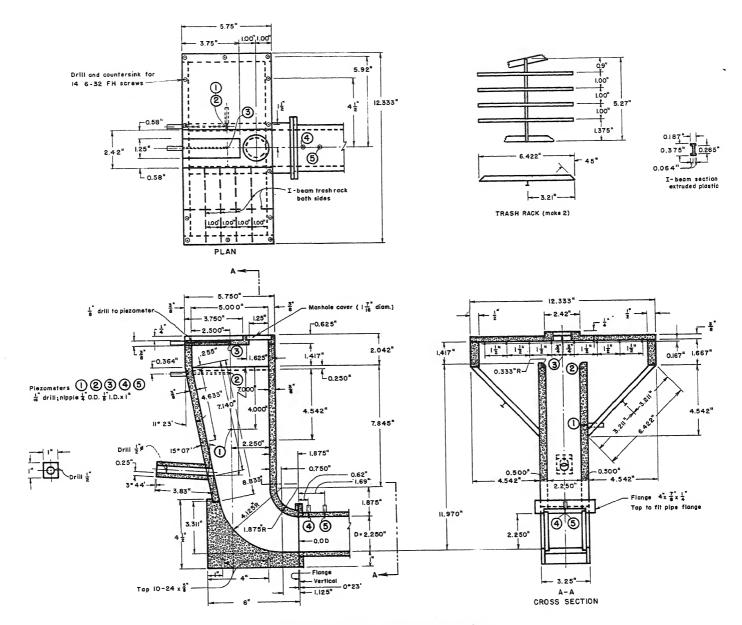
Figure 7.—Model drop inlet dimensions.

Piezometers to measure the pressures in the drop inlet and at the barrel crown are shown in figure 7: number 1 at the drop inlet midheight, number 2 at the end on the sidewall crest curve, number 3 at the center of the antivortex plate, and numbers 4 and 5 on the barrel crown near the barrel entrance. Additional piezometers were located at 10D intervals along the barrel invert, the first piezometer being 15D from the barrel entrance. These were used to determine the hydraulic gradeline and friction loss in the barrel.

As shown in figure 7 pressures in the drop inlet were measured at the drop inlet midlength at two elevations: at the midheight (piezometer 1) and at the end of the crest curve (piezometer 2), and at the center of the antivortex plate (piezometer 3). Pressures were also measured on the barrel crown 0.052D (piezometer 4) and 0.141D (piezometer 5) downstream from the drop inlet.

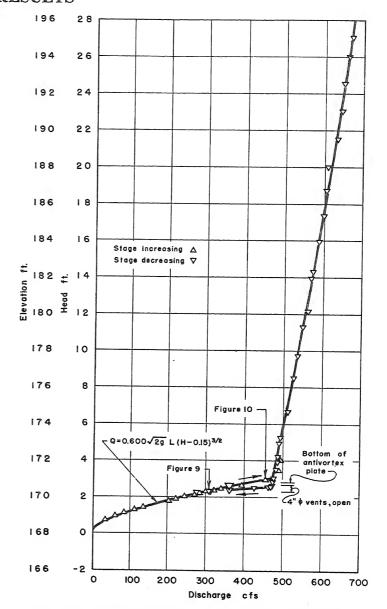
Figure 8.—Model head-discharge relationship: vents open.

The head-discharge relationship with open ports in the endwalls is shown in figure 8. Although figure 8 has been expressed in prototype units, quantitative model-prototype similarity does not exist for full flow because of the different barrel lengths and the omission of the energy dissipator. However, similarity for weir flows should exist.

The head-discharge relationship is unique for rising and falling stages except for the hysteresis effect as the control changes from pipe to weir on falling stages. This hysteresis is believed to be caused by inadequate ventilation because, during the falling-stage hysteresis portion of the head-discharge curve in figure 8, the vents are partially submerged and apparently are unable to fully supply the venting requirements.

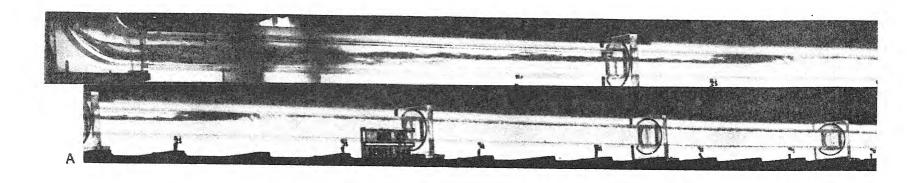
Unstable flow existed in the barrel at discharges of 300 to 320 c.f.s. There was a hydraulic jump in the barrel. The air entrained in the jump was transported as small bubbles (fig. 9(a)) or larger slugs (fig. 9(c)) on the barrel crown. The jump position was unsteady, slowly moving back and forth in the barrel or remaining

Figure 9.—Various flow conditions in the barrel, discharge 309 c.f.s. (The upper section of each photograph shows the bottom of the drop inlet and the barrel from 0D to 35D, the lower section shows the barrel from 20D

to 85D.) (A) Hydraulic jump in barrel at 27D from barrel entrance. (B) Jump has moved to upstream end of barrel. (C) Jump at 12D and long air slug from 31D to 77D.

semistable at some position between 60D and 0D from the barrel entrance (figs. 9(a) and 9(b)). The weir nappes were clinging and the drop inlet was part full.

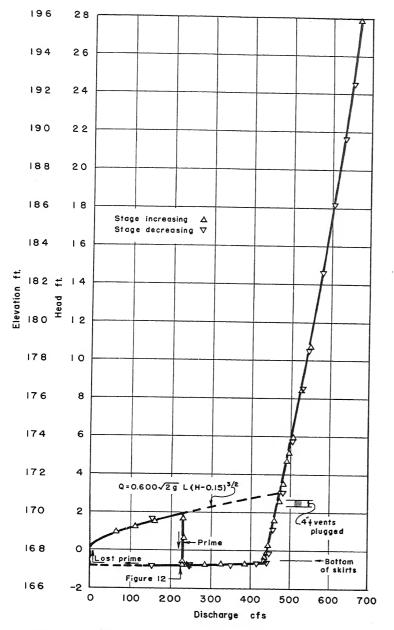
Figure 11.—Model head-discharge relationship: vents closed

The head-discharge relationship with the endwall vents plugged is shown in figure 11.

As the discharge increased from 229 to 433 c.f.s., the drop inlet gradually filled and the air entering under the skirts gradually decreased. One of the weir nappes clung and the other sprung free.

There were surface vortices at the ends of the antivortex plate for heads between 2.5 and 11 ft. Air bubbles were trapped under the upstream outside corners of the antivortex plate at heads exceeding 4 ft. Air was trapped over the drop inlet at a discharge of

500 c.f.s. and the pressure blew off the manhole cover, an event which was observed only once during the tests.

For decreasing stages the spillway remained primed until the discharge decreased to 153 c.f.s. When the spillway lost its prime the discharge suddenly decreased to zero since the weir head was then -0.8 ft. Because the inflow to the headpool was also 153 c.f.s., the reservoir filled to the drop inlet crest without outflow and further filled to a stable weir head of 1.6 ft with outflow.

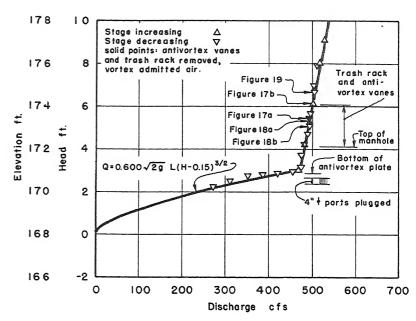
Figure 16.—Model head-discharge relationship: vents closed, manhole cover removed, trashrack and antivortex device over manhole.

Similarly, the trashrack cover was used only after the trashrack and antivortex vanes became submerged. At times during the tests the trashrack and antivortex device were removed to see if vortices would form; they did.

At heads below 4.1 ft the antivortex device was not submerged and no vortices were observed. Removal of the antivortex device permitted strong vortices to form and admit air to the spillway at heads of 5.6 to 4.7 ft. At a head of 4.7 ft some "bouncing" of the water surface over the manhole was observed with the antivortex vanes in place. Without the antivortex device no vortices were observed over the manhole when the water surface barely covered or was below the top of the antivortex plate (heads from 4.2 to 3.2 ft).

As a result of this investigation, the authors recommend that the manhole cover be removed, that an antivortex device and trashrack be installed at the manhole opening, and that nothing be done regarding the vent holes in the antivortex plate endwalls.

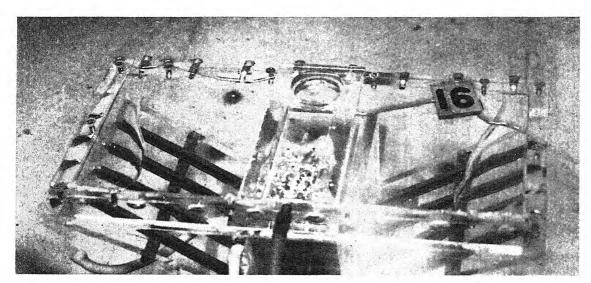
Figure 20.—Little loss in head between the headpool and drop inlet. Water is standing in the manhole opening. The head on the spillway crest is 3.7 ft, 0.9 ft above the bottom of the antivortex plate. The pressure at the center of the antivortex plate is 0.5 ft. The pressure drop between

the headpool and the cover over the center of the drop inlet is only 0.4 ft or $-0.04h_{vp}$. Air is trapped over the upstream end of the drop inlet and upstream outer ends of the antivortex plate.
